# Coastal Hazards Vulnerability Assessment of Public Infrastructure Down East & Adjacent Communities, Carteret County, North Carolina

August 2026

Katie M. Peek, Holli L. Thompson, & Robert S. Young  
Program for the Study of Developed Shorelines  
Western Carolina University  
Cullowhee, North Carolina 28723

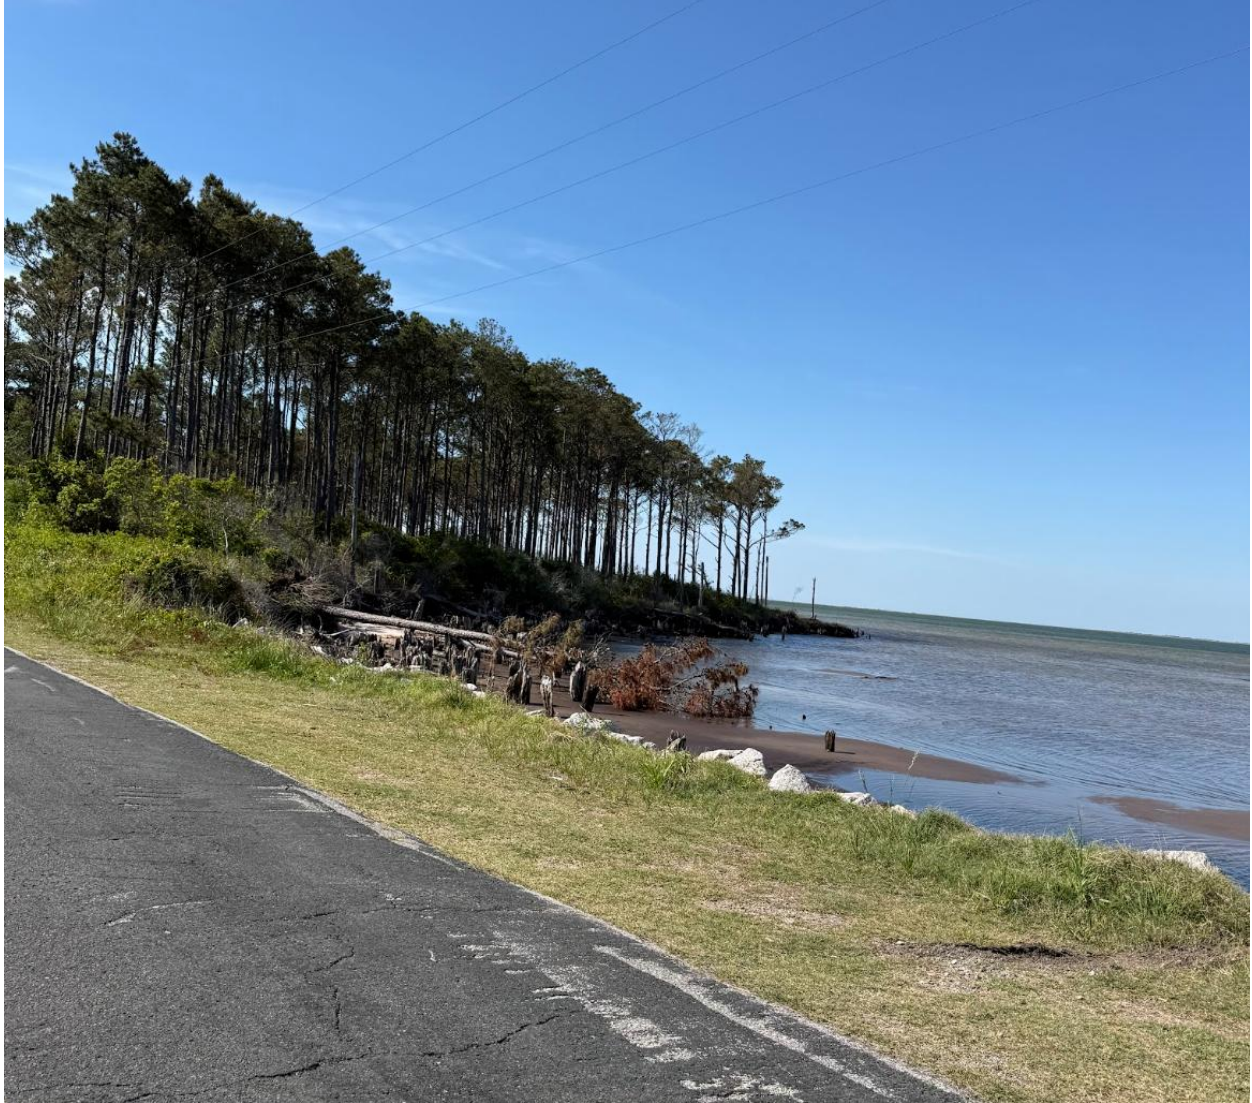
**This Page:** Erosion along Lola Road in Cedar Island, NC. Photo credit: Program for the Study of Developed Shorelines at Western Carolina University.

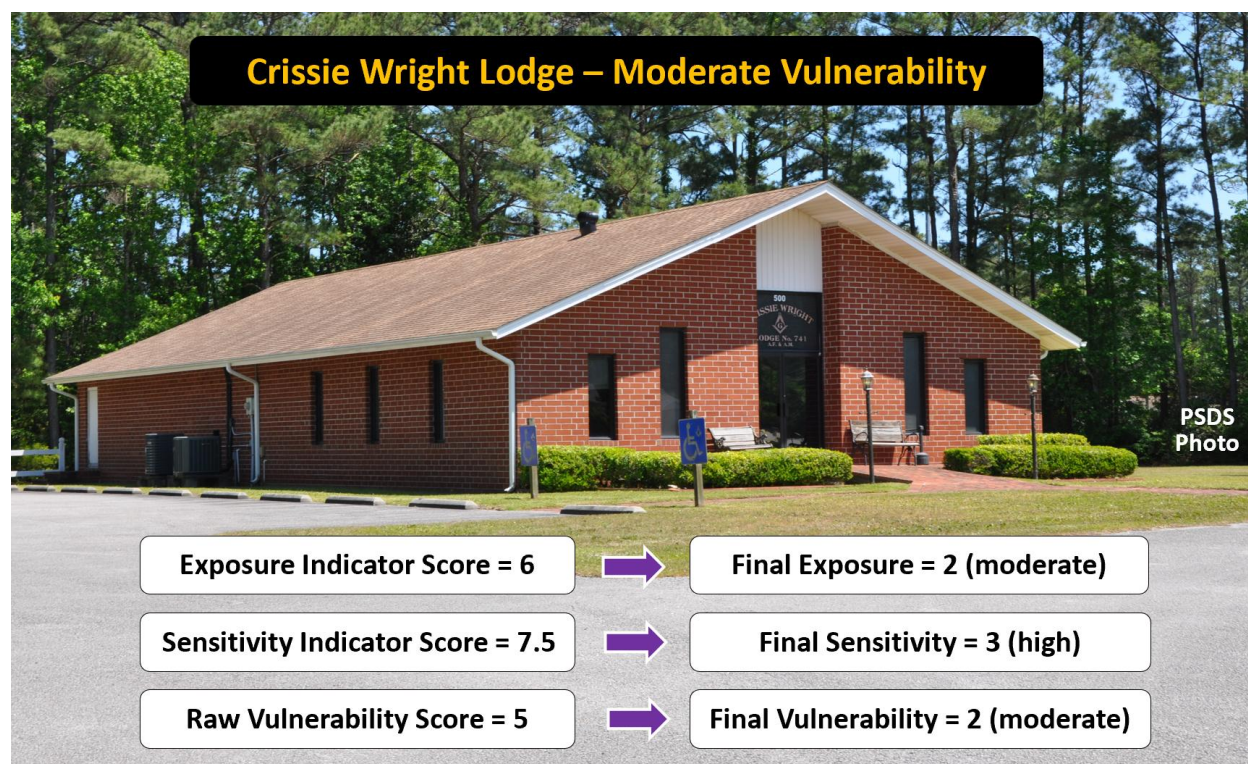
**Figure 5.** Final exposure, sensitivity, and vulnerability scoring for Crissie Wright Lodge in Smyrna.

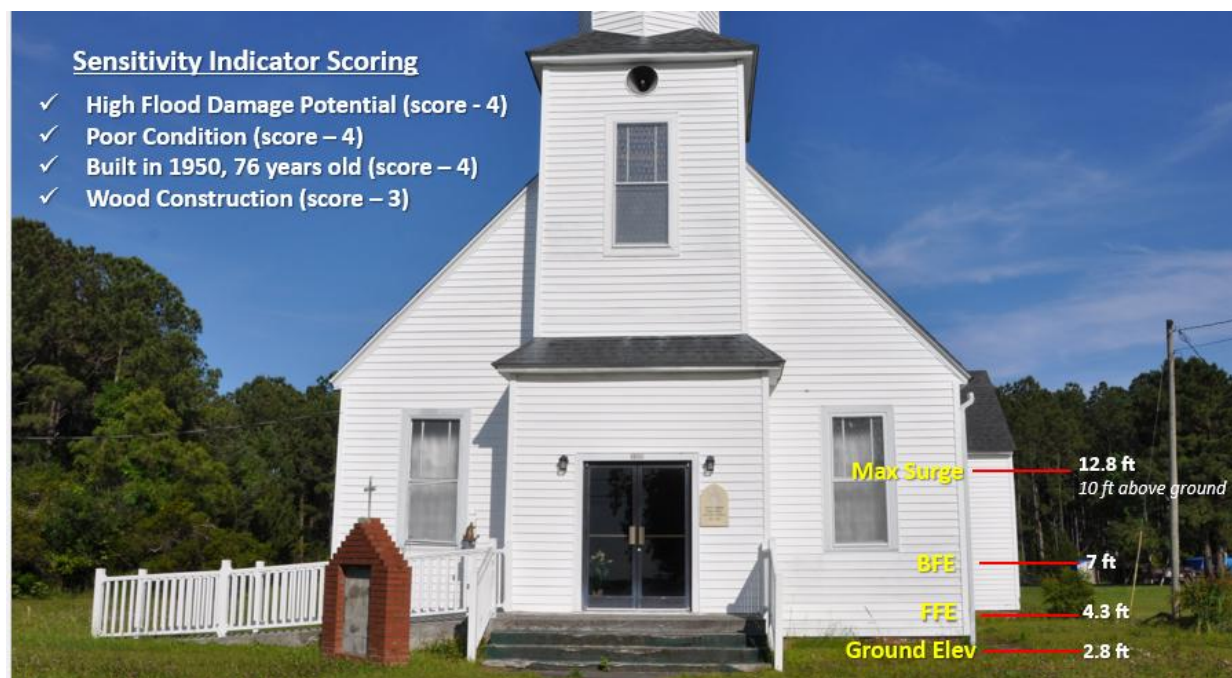
Only one asset, Sea Level Free Will Baptist Church, has **very high** sensitivity (Table 15). This church (which was flooded and is now abandoned) has the worst possible score (four) for all sensitivity indicators except construction type (Figure 13). Twenty-seven buildings have **high** sensitivity (Table 15), including 17 churches, three community centers, and four fire departments/stations (Merrimon, Marshallberg, Cedar Island, and Sea Level). Less than half (45%) of the buildings analyzed have **moderate** sensitivity, while 11% have **low** sensitivity. The buildings with the lowest total indicator (raw) score for sensitivity are Hunting Quarters Baptist Church, Lighthouse Chapel Church & School, and Grace Holiness Church. See Appendix tables B1-B4 for all Down East building sensitivity results.

**Figure 13.** Sensitivity indicator scoring for Sea Level Free Will Baptist Church, the only asset evaluated with very high sensitivity. Also illustrated are the potential flood heights as predicted by the FEMA AE zone and category 3 storm surge. All measurements are in feet above NAVD88 unless otherwise noted. Illustration of flood heights on church exterior are estimates and not to scale.
