# Coastal Hazards Vulnerability Assessment of Public Infrastructure Down East & Adjacent Communities, Carteret County, North Carolina

August 2026

Katie M. Peek, Holli L. Thompson, & Robert S. Young  
Program for the Study of Developed Shorelines  
Western Carolina University  
Cullowhee, North Carolina 28723

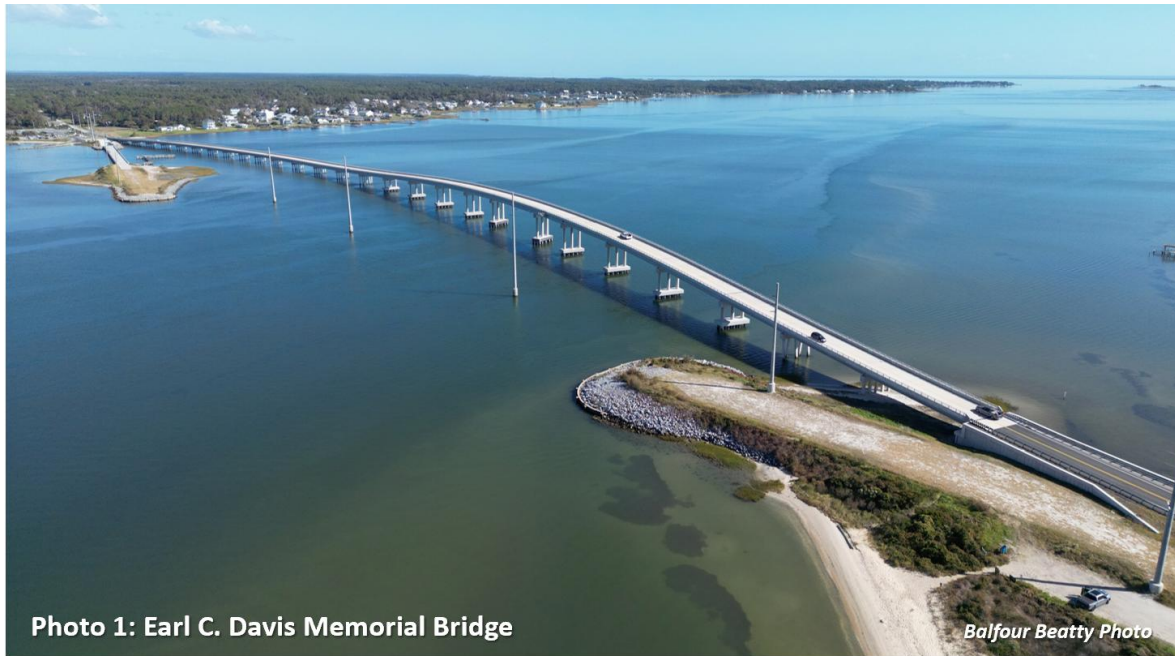
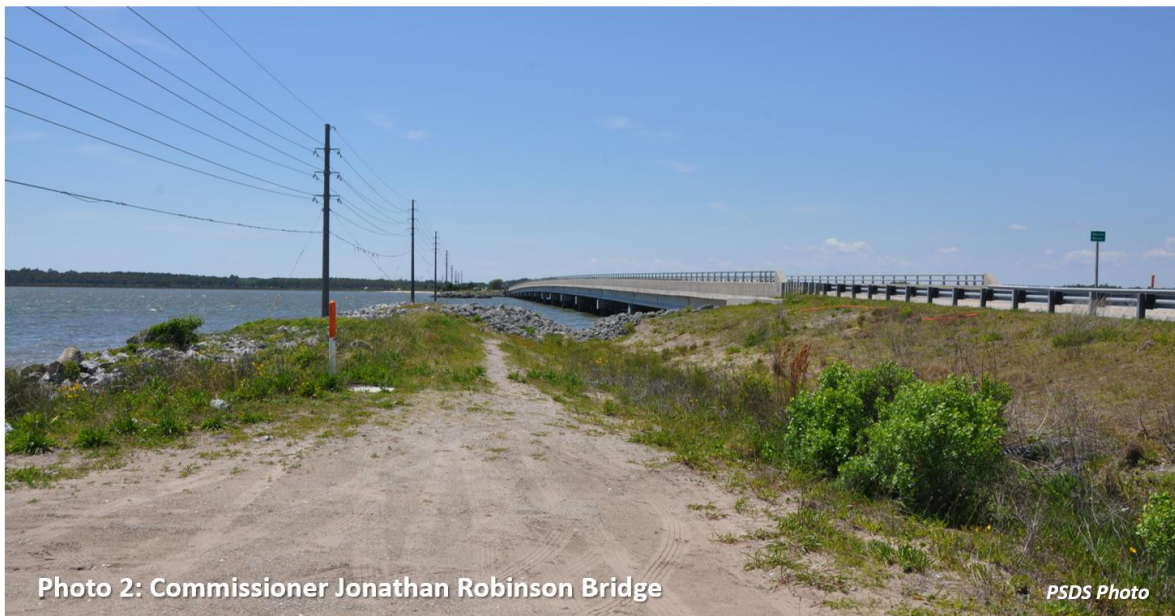
None of the bridges included in this assessment have **very high** or **high** sensitivity (Table 15). The majority (71%) of the bridges have **moderate** sensitivity, and 29% have **low** sensitivity. Because bridges over water inherently have high exposure, they are commonly built resistant and have a lower sensitivity compared to other asset types. The two lowest sensitivity bridges (Earl C. Davis Memorial Bridge and Commissioner Jonathan Robinson Bridge) have high waterway adequacy (chance of overtopping deck is remote, slight chance of overtopping approaches), are less than 10 years old, are in good or better condition, and are stable relative to scour potential (Photos 1-2). See Appendix table B5 for all Down East bridge sensitivity results.
